ANALYSIS OF PLANE CRASH IN NIGERIA AND LESSONS LEARNED FROM SPECIFIC DISASTER: DANA AIR 0992, 5N-RAM CRASH

Geoffrey Chinweuba Elele and Ugochukwu Akachi Elele

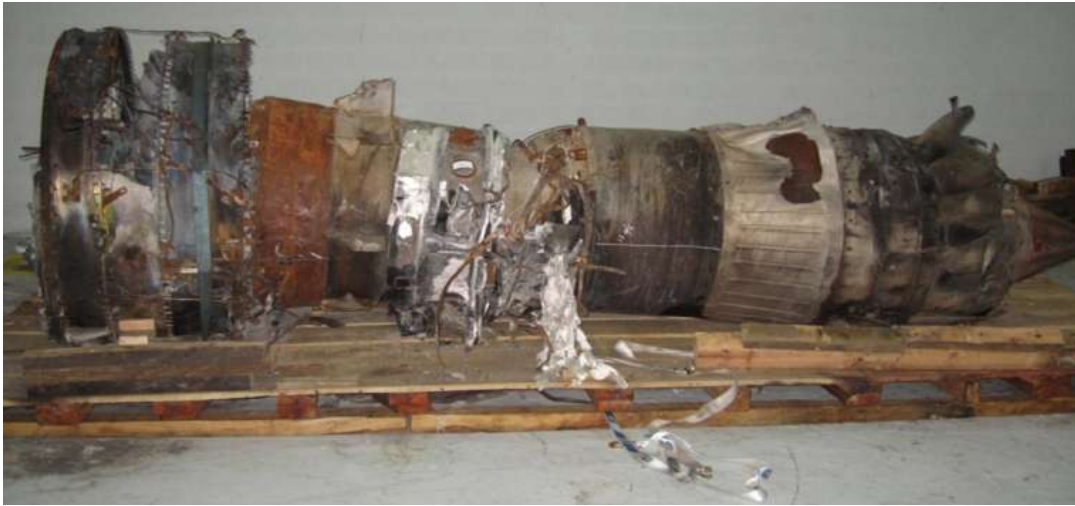
(DANA/2012/06/03/F), during the impact sequence of the crash, the aircraft collided with an unfinished building, two trees, and three other buildings. Figure 2: shows the top view of the aircraft's number one turbine engine after the crash impact at the crash site.

Figure 2: Top View of Engine 1; culled from DANA/2012/06/03/F report

1. Design flaws in the primary and secondary fuel manifold assemblies of the aircraft were the primary technical cause of the accident. Both engines' primary and secondary fuel manifold assemblies were fractured, cracked, bent, twisted, or pinched, resulting in fuel leaks, fuel discharge to the bypass duct, loss of engine thrust, and obviously, failure of the engine to respond to throttle movement.

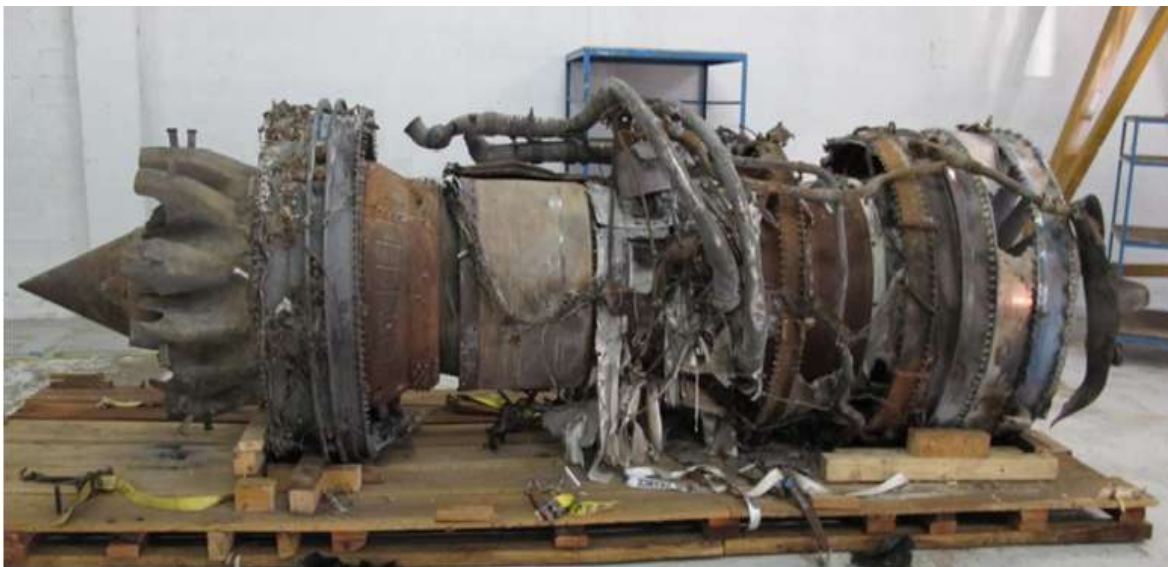
3. The final aspect of the technical failure was the flight crew's inability to recover engine power. Components of the direct causes include the flight crew's failure to use the checklist, lack of situational awareness or poor airmanship, and failure to land at the nearest suitable airport. Figure 3, shows the right hand side of the aircraft's turbine engine on a pallet at the crash site.

Figure 3: Right Hand Side of Engine 2, culled from DANA/2012/06/03/F report

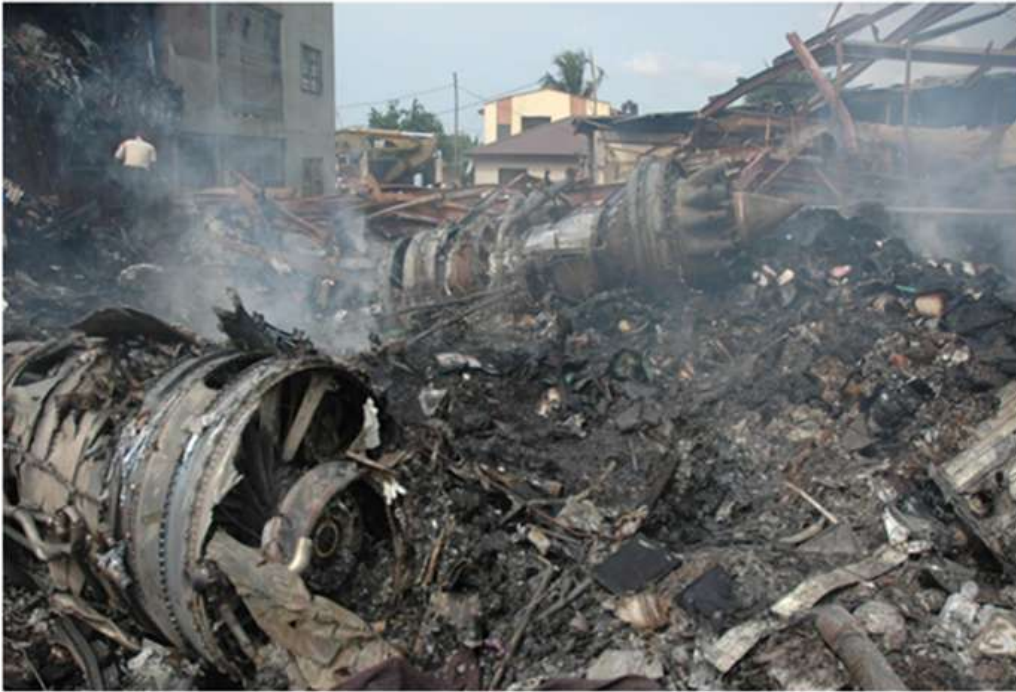
breathing and transported to the hospital after the impact would have survived. Figure 4, shows the gory site of the aircraft's wreckage at the crash venue.

Figure 4: Wreckage site of the Two Engines culled from DANA/2012/06/03/F report

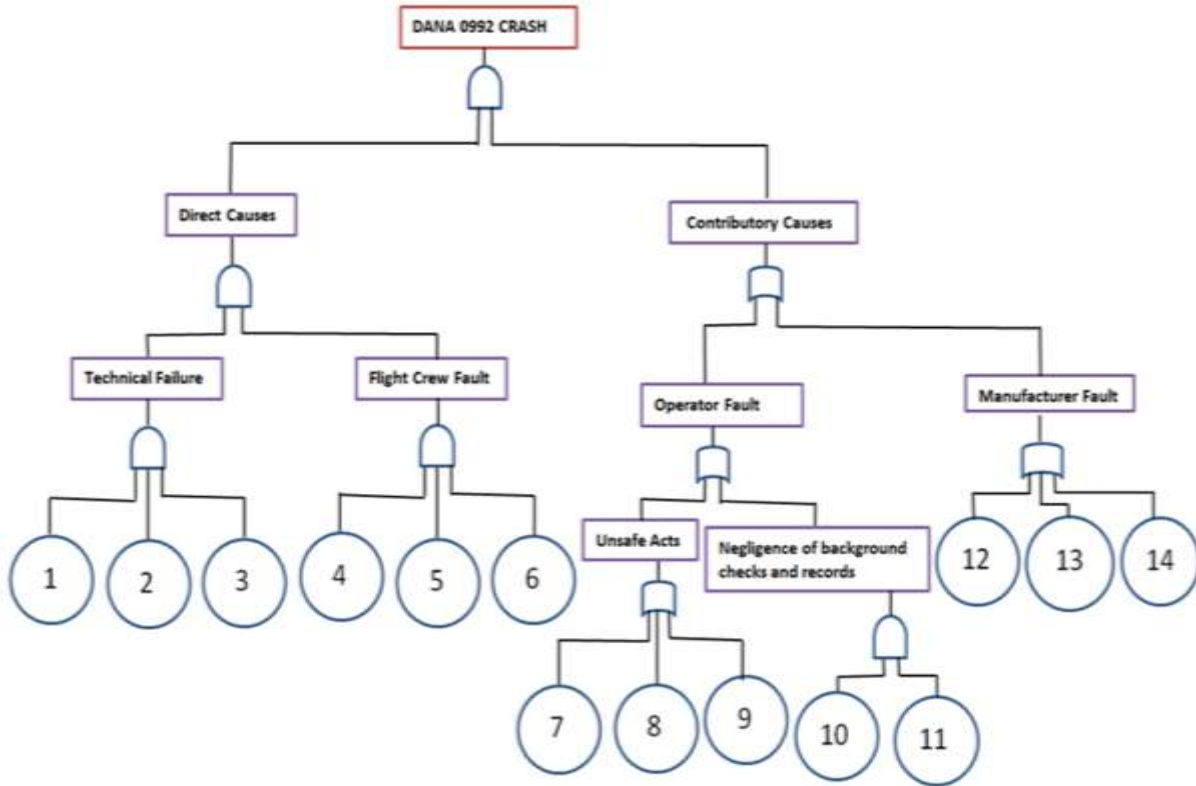
Figure 5 depicts the Fault Tree Analysis (FTA) of the plane crash, in which the direct cause and contributing causes have been identified. Figure 6 shows the resulting Reliability Block Diagram (RBD). The primary actor in the direct cause is technical failure. The fact that the loss of engine No. 1, the loss of engine No. 2, and the failure of the engine power recovery system are all connected to an AND-gate demonstrates that their concurrent failures led to the failure of the system, or the crash of the aircraft.

The second factor in the direct cause was the flight crew's error, as evidenced by their failure to use the checklist, lack of situational awareness, poor airmanship, and failure to land at the nearest appropriate airport. The contributing factors include OR-gate remarking errors from DANA management, the operator, and the aircraft manufacturer. The operator conducted her flight operations under risk normalization through unsafe acts, including noncompliance with Service Bulletin SB6452, which is a safety alert, non-involvement of the QC department in the pilot hiring process and the use of a different batch of aviation fuel from a different refinery during the flight. These unsafe acts are linked sequentially in the RBD, demonstrating their vulnerability to the Dana airline management and the entire system. More focus and resources should be devoted to this series events, as the failure of any one of them could result in the loss of the entire aircraft system. In addition, the operator was insensitive to the deluge of negative comments made about the captain during; background checks, test flights, and in flights and recall records for a similar engine fault. The second component of the contributing factors is the fault of the aircraft manufacturer. An OR-gate is connected to the cause events 12, 13, and 14, which are defects in the structural design of the primary/secondary fuel manifold, imbalance in work rate between No.1 and No.2 engines at installation relative to their operating hours/cycles, and failure to recall all aircrafts operating with the faulty secondary manifold assemblies. This relationship demonstrates that the failure of any one of them could have contributed to the system failure that resulted in the airplane crash. The RBD sheds more light on the relationship between the plane crash's direct and contributing causes.

Figure 5: Fault Tree Analysis of DANA 0992 Air Crash

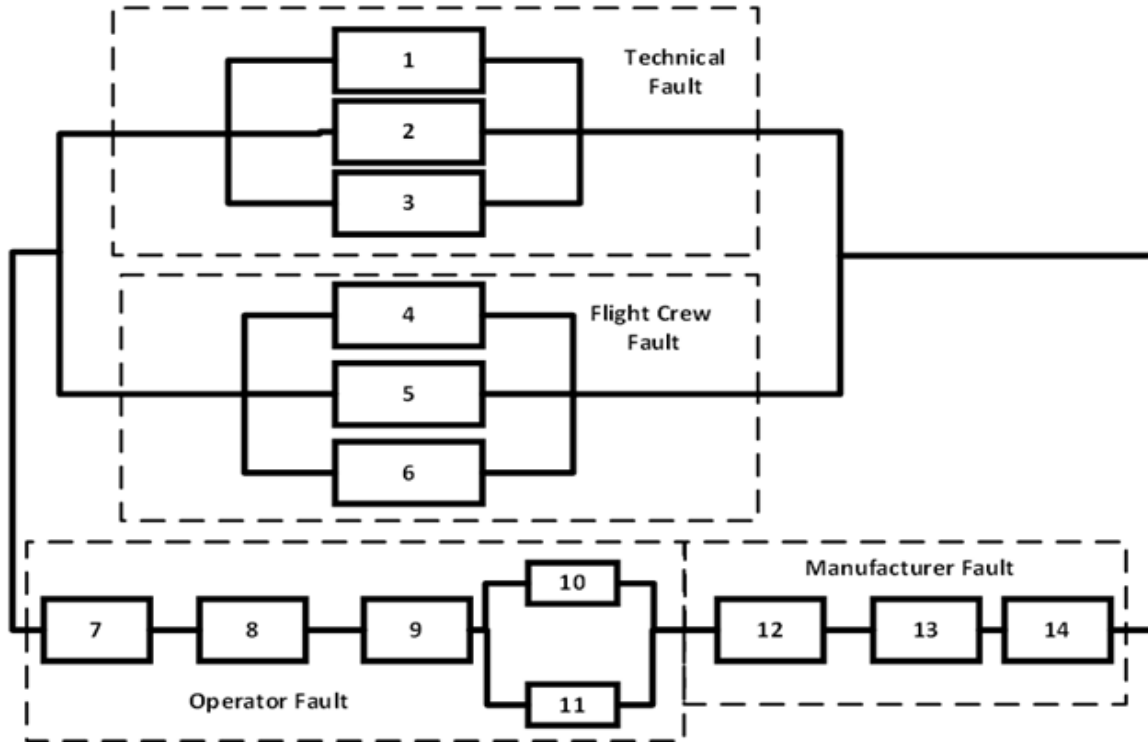
However, the system's vulnerability is made more glaring by the arrangement of the blocks which constitute the events of the contributing causes.

Figure 6: Reliability Block Diagram (RBD) of DANA 0992 Crash

The minimal cut set, the smallest group of fault initiators whose failure causes system failure, can be deduced from the events 7, 8, 9, (10&11), 12, 13 and 14. All airline operators should not ignore or violate the DANA 0992 plane crash's unsafe acts, negligence of background checks/records, and manufacturer's faults. The FTA captured failure probabilities and logical causative factors, while the RBD revealed system vulnerabilities. These two reliability techniques have improved understanding of the air crash.
