#### MECHANISTIC ANALYSIS OF EARLY PAVEMENT DETERIORATION: APPLICATION TO THE GASSI - DOURBALI SECTION

**Maucord Mougabé Belem, Djegoldé Kormbaye and Nadjitonon Ngarmaim.**

Industrial Technologie Study and Recherch Laboraty (LERTI) at the University of N'Djamena Civil Engineering Laboratory (LABOGECE).

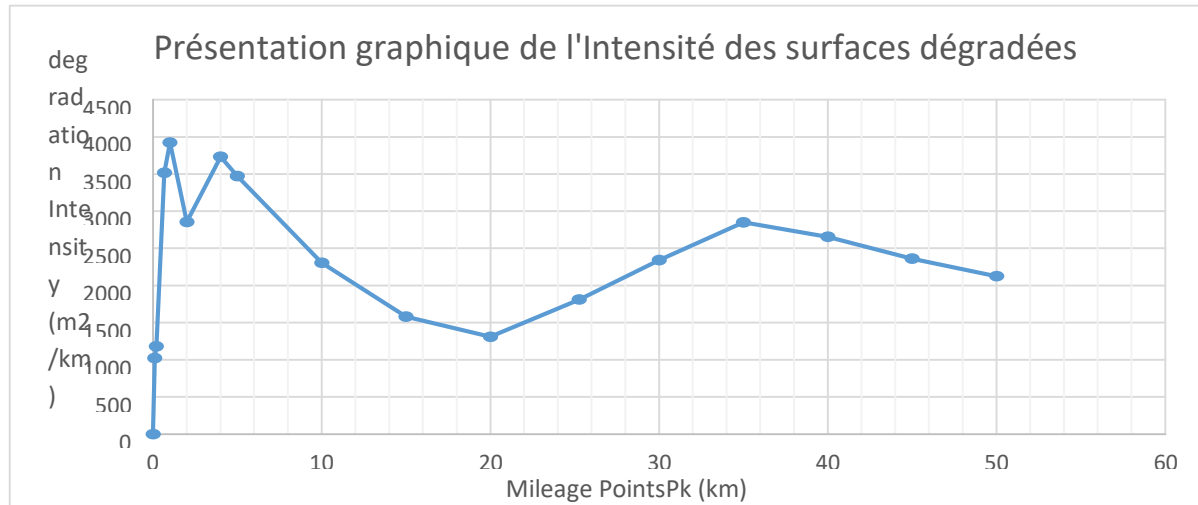
**Figure 2:-** Trend curve of pavement deterioration.

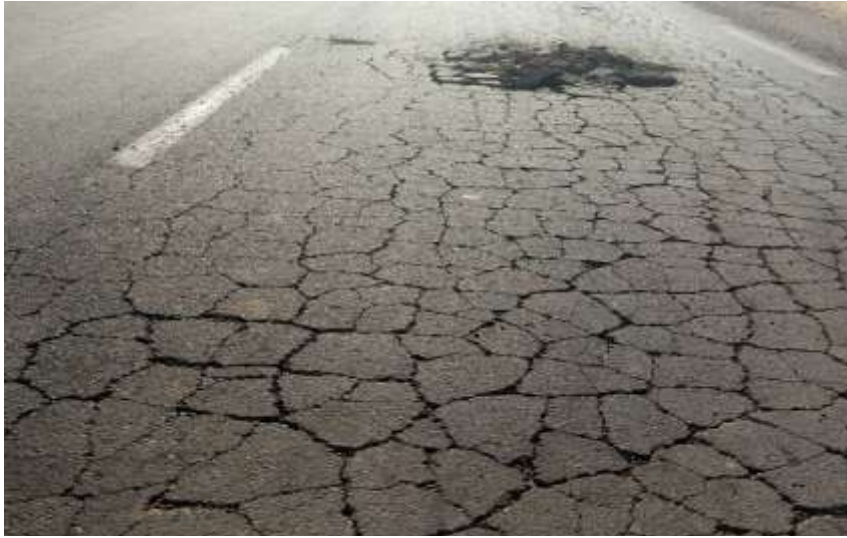
**Figure 3:-** Pavement crazing.

Looking at this photo, we can see a large hole in the pavement and widespread cracking with deep cracks.

The hole is due to punching of the already cracked surface. Wind and water, plus heavy goods vehicle traffic, were among the potential causes of this localised deterioration. This allows us to accept that heavy goods vehicles overloaded the pavement.

As for the faience, it is the opening of surface cracks on the asphalt concrete that has lost its adhesion with the base layer. The reasons for this can range from the way the bitumen is applied, depending on the temperature and climate at the time, to the phasing time between successive layers.

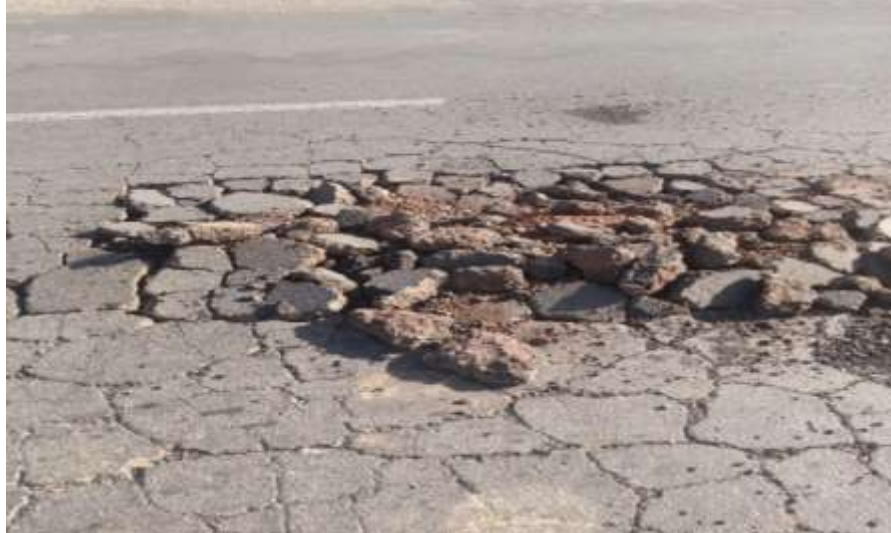
**Figure 4:-** View of cracking and destruction of pavement.

This example of pavement deformation gives the impression that there was no bonding layer before the asphalt concrete. The structure of the asphalt itself could be involved. It is a break in a composite aggregate of materials placed in bulk by a tremor. This breakage assumes that there was a void between the base layer and the bituminous concrete, as we showed above in theory. The over-compaction of the base layer may also be at the origin of its rigidity and the rapid drying of its face before the application of the bituminous concrete may also be the cause of this brittleness of the GNT.

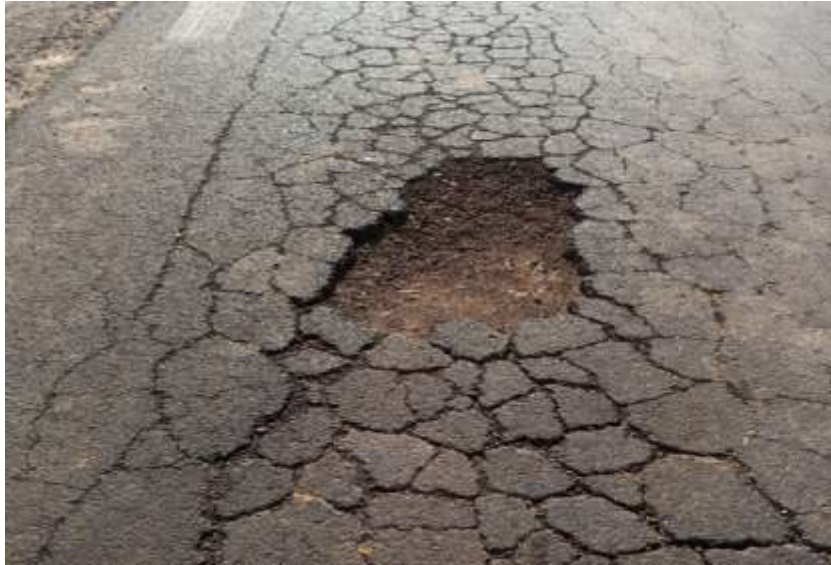
**Figure 5:-** View of a pothole in the middle of the cracks.

This photo shows a deep pothole where the base layer has been reached. This base layer has, of course, disintegrated without cohesion. The tiles surrounding the pothole are already in loose patches. All it will take is the braking of a vehicle or some kind of traction force to tear them apart. The base course should be protected by the wearing course. The structure of this base course also reveals a non-conforming grading.

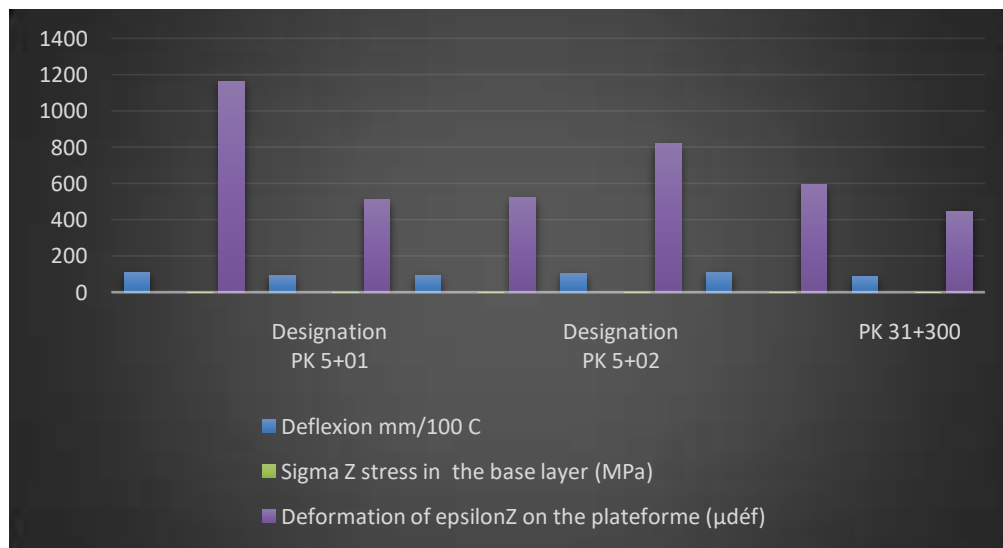
**Figure 6:-Deflection – deformation.**

This figure shows that the vertical deformation of the platform follows the general deflection and varies according to the vertical stress borne by the base layer. The values or orders of magnitude vary according to the kilometre points (KP). Overall, with the exception of kilometre point KP 31+300, the deflection values are greater than 90, which is the maximum permissible limit for values expected from field measurements. This indicates that the materials used in the construction of the carriageway were of low bearing capacity.
