## INTERNATIONAL JOURNAL OF ADVANCED RESEARCH (IJAR)

#### EVALUATING THE FIRE PROTECTION SYSTEM AT LAMPUNG CITY MALL USING FAULT TREE ANALYSIS

This study evaluates the fire incident that occurred in the kitchenware storage area on the ground floor of Lampung City Mall, caused by an LPG gas cylinder. The study's objective is to identify the root causes of the fire, assess the adequacy of active fire protection systems, compare them to the applicable regulations and standards, and evaluate the communication hazard in Lampung City Mall. Recommendations for improving safety communication are provided. The findings indicate that the active fire protection system meets 88% of the required standards, which falls under the "GOOD" category, meaning all elements are functioning properly and in accordance with regulations. As for evacuation safety, the system meets 85% of the requirements, which also falls under the "GOOD" category. However, the study concludes that there are still several fire safety symbols that urge to be added in order to improve the safety communication at Lampung City Mall.

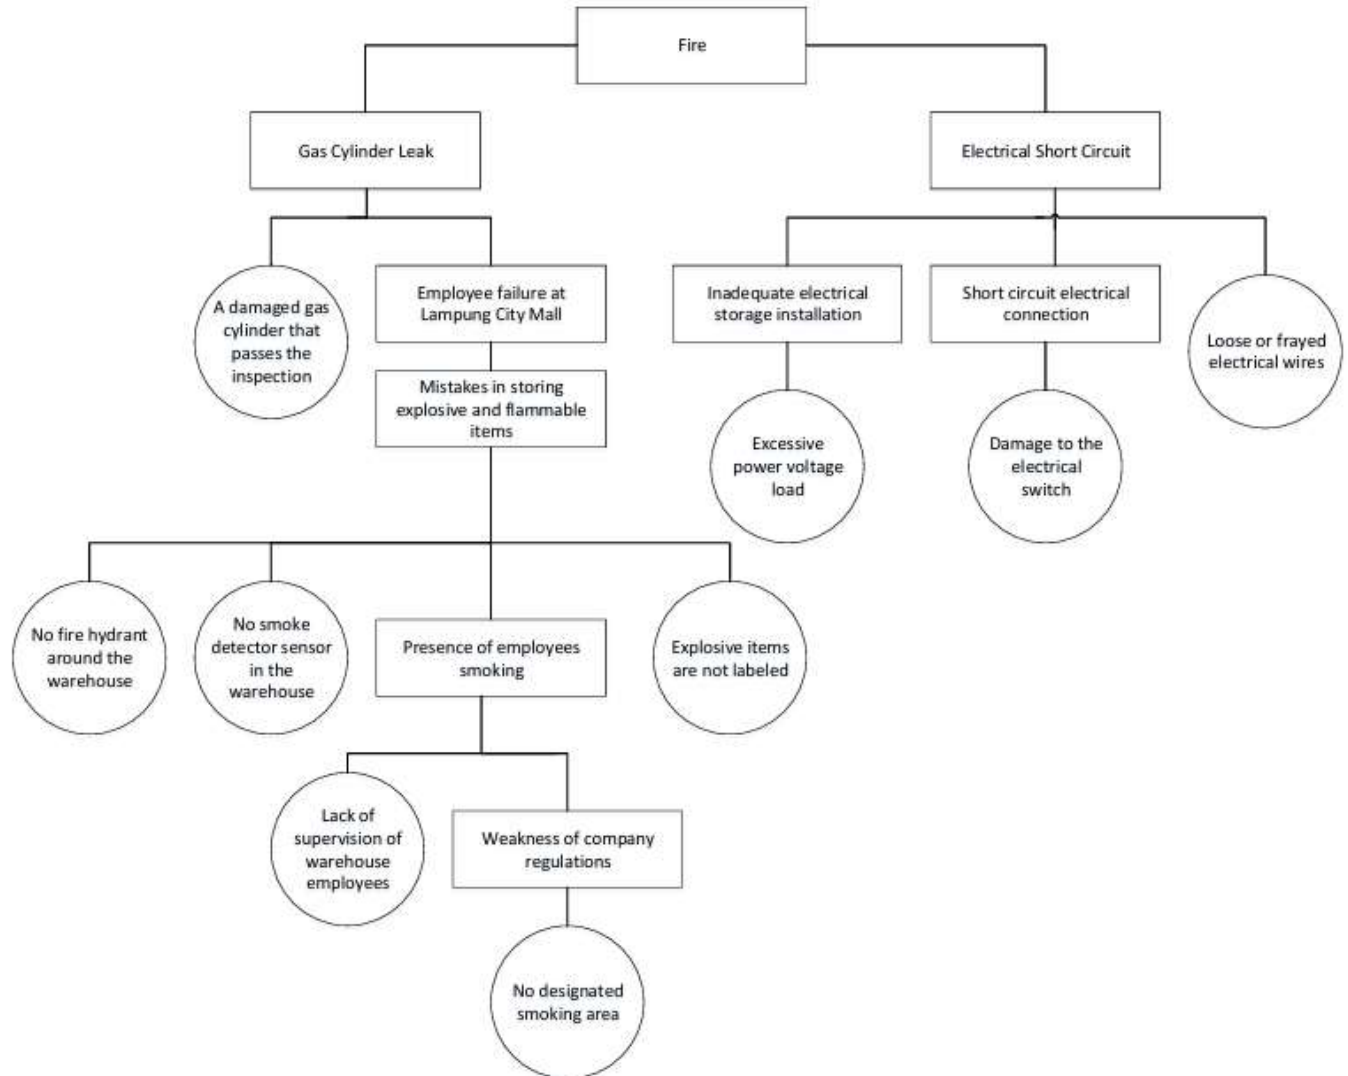
Figure 3:- The Fault Tree Analysis Diagram.

The Fault Tree Analysis diagram above explains that the fire at Lampung City Mall was caused by two main factors:

1. **Gas Cylinder Leak:** caused by a basic event of a damaged gas cylinder that passed inspection by the warehouse employees and an intermediate event of Lampung City Mall employee failure, or mistakes in storing explosive and flammable materials. Improper storage of goods led to the fire incident, compounded by the lack of a fire hydrant around the warehouse, no smoke detector in the warehouse, and employees smoking in the area. Another contributing factor was the absence of danger labels on explosive and flammable items. The smoking by employees was attributed to a lack of supervision over warehouse employees and weak company regulations at Lampung City Mall. This weak regulation was linked to the lack of designated smoking area.

2. **Electrical Short Circuit:** caused by an intermediate event of insufficient electrical containment installation that triggered by an excessive power voltage load, an intermediate event of short circuit electrical connection that led to damaged electrical switches a basic event of loose or frayed electrical wires.

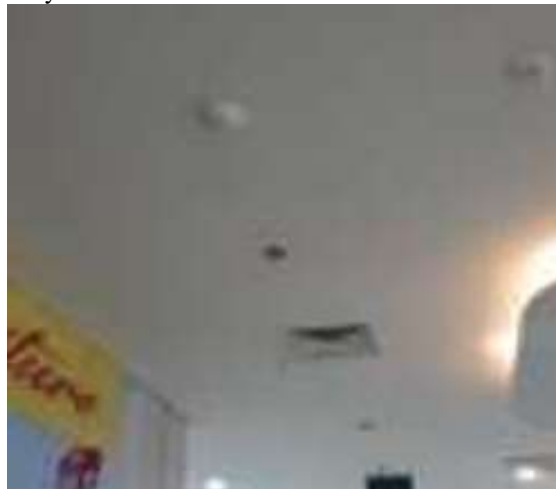
**Figure 4:-** Fire Alarm and Detector Protection System.

Based on questionnaire results, it was found that the fire alarm system in Lampung City Mall is fully installed (100%) throughout the building, meeting the standard SNI 003-3985-2000. The fire alarm system at Lampung City Mall is integrated with the hydrant system.

Lampung City Mall has a total of 72 detectors, with 12 on each floor. However, these detectors have only been inspected once since installation, which took place during initial setup, and no subsequent inspections have been conducted.

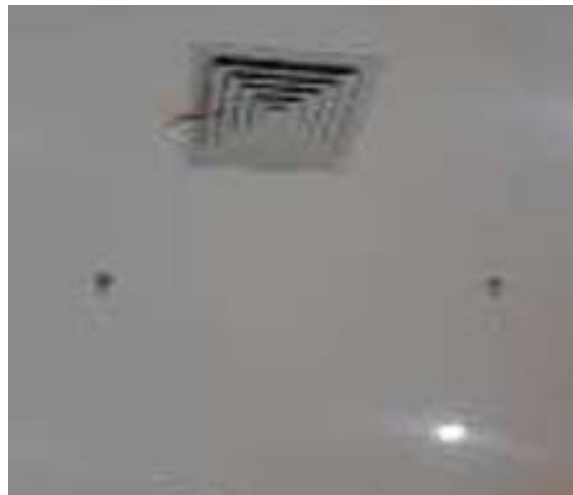
**Figure 5:-** Fire Sprinkler Protection System.

Sprinklers comply with SNI 03-3989-2000 standards. Like the detectors, sprinklers are installed throughout each floor, although they are missing around the warehouse area and certain lower floors. The sprinklers have only undergone one inspection since initial installation.

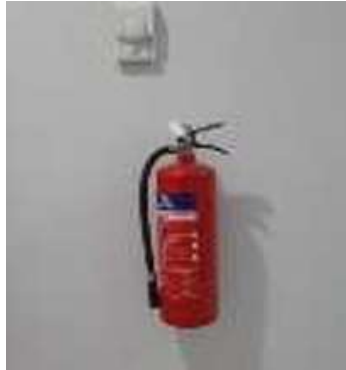
**Figure 6:-** APAR Protection System.

Portable fire extinguishers (APAR) were assessed based on the Minister of Manpower Regulation No. 04/MEN/1980 and Minister of Public Works Regulation No. 26/PRT/M/2008. According to the questionnaire and observations, Lampung City Mall has 54 fire extinguishers, with nine located on each floor. These are inspected at least twice a year, and all inspection records are well-maintained.

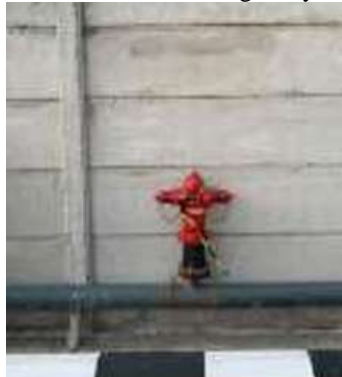
**Figure 7:-** Hydrant Pillar Fire Protection System Outside LCM Building.

Hydrants were assessed against the SNI 03-1745-2000 standard. Observations revealed that the hydrants include four outdoor hydrants and two indoor hydrants. Functional testing of hydrants is performed routinely once a year.

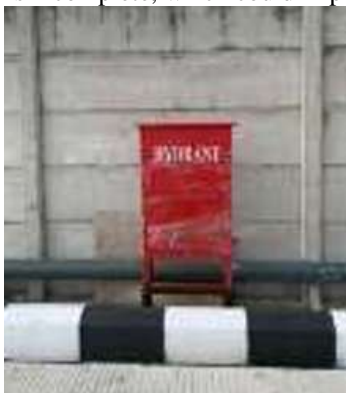
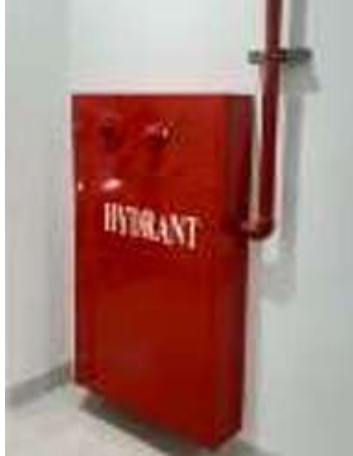
The hydrant boxes at Lampung City Mall are easy to open, visible, and accessible. The hydrant boxes are painted red with the word “Hydrant” in white. However, there are no instructions for proper hydrant use inside the boxes, and the hydrant equipment in all locations is incomplete, which could impede emergency use.

**Figure 8:-** Fire Protection Hydrant Box Outside LCM Building

**Figure 9:-** Fire Protection Hydrant Box Inside LCM Building.

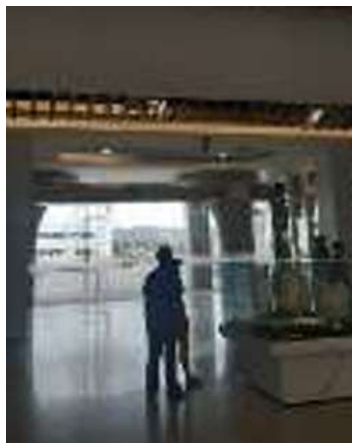
**Figure 10:-** Life Safety Facility - Emergency Exit at Lampung City Mall.

The compliance of emergency exits was compared to NFPA 101 and SNI 03-1746-2000 standards. Lampung City Mall has two emergency exits that are unobstructed and connect directly to an open area outside the mall. Given that Lampung City Mall is the largest mall in Lampung, the adequacy of two emergency exits is assessed as 60% compliant, categorizing it as "adequate." This indicates that, while the exits are present, they do not fully meet the standard requirements for a building of this size.

The non-compliant elements include exit routes, which are insufficient for a large, six-story mall. Lampung City Mall only has two exit doors. In the event of a fire, especially when crowded, visitors may panic and cause congestion as they try to escape.

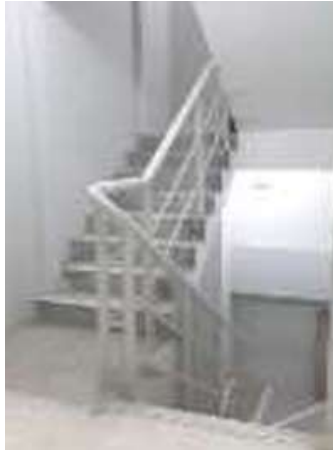
**Figure 11:-** Life Safety Facility - Emergency Stairs at Lampung City Mall.

Observations showed that emergency stairs are available on each floor, achieving a 100% compliance rate, meaning that these elements meet all regulatory requirements.

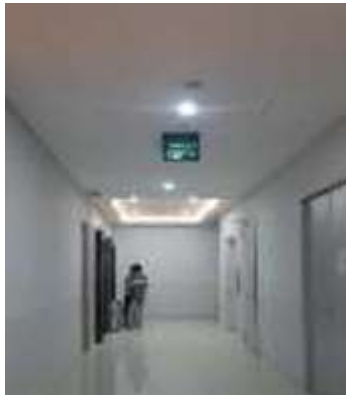
**Figure 12:-** Life Safety Facility - Exit Signage at Lampung City Mall.

Observations indicated that exit signs throughout the mall mostly meet NFPA 101 and SNI 03-1746-2000 standards, achieving a 100% compliance rate. The installed signs, including "EXIT" markings, are well-suited to guide visitors in an emergency.

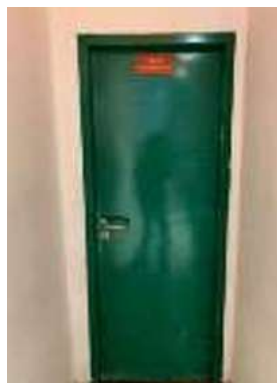
**Figure 13:-** Life Safety Facility - Emergency Doors at Lampung City Mall.

Observations confirmed that Lampung City Mall has numerous emergency doors accessible to mall visitors. The compliance rate is 100%, indicating that emergency doors are installed according to requirements.

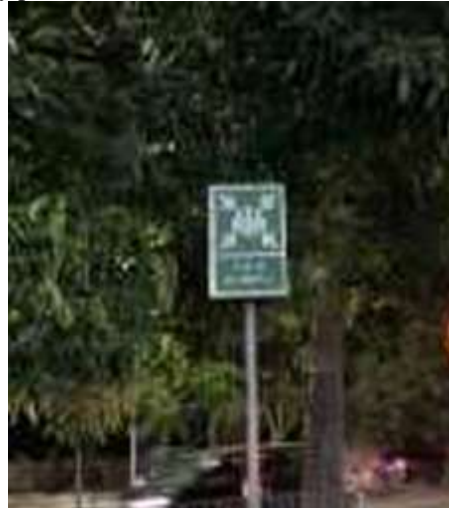
**Figure 14:-** Life Safety Facility - Assembly Points at Lampung City Mall.

Compliance of assembly points was evaluated against NFPA 101's life safety code. Field observations show that Lampung City Mall has two assembly points.

While the mall has designated assembly points, the number may be insufficient given that Lampung City Mall is Lampung's largest mall. For assembly points to be considered fully compliant, they must meet several criteria set by the NFPA 101 (2000), including:

Another element identified as non-compliant is the assembly point. Additional assembly points are needed to accommodate mall visitors, apartment residents, and other building occupants, as Lampung City Mall is integrated with other facilities.

The current assembly points are located in open, safe spaces that facilitate easy evacuation. However, to meet full compliance, additional or larger assembly areas should be considered to accommodate all mall occupants safely during an emergency.

No.	Existing Condition	Expected Condition	Recommendation
1	Lack of Assembly Point Symbols and Accessibility Issues	The assembly point should be easily accessible from areas served by easily reachable exits.	It is recommended to add symbols and an assembly point near the building's exit doors so that mall visitors can easily evacuate themselves in the event of a fire hazard.
2	Emergency Doors Lack "PUSH" Signs, and Their Location is Hard to Reach from the Evacuation Corridor	Emergency doors should be easily accessible and visible.	Fire doors should be located in an easily accessible place, not convoluted or far from the evacuation corridor. Adding "PUSH" signs would help users to open emergency doors easily.
3	Lack of Hazard Symbols on Explosive and Flammable Items	There should be hazard symbols for items that are explosive or flammable.	It is advisable to add hazard symbols for explosive or flammable items stored in the warehouse and throughout the mall to prevent future fires.
