## POOR FLEXURAL REINFORCEMENT PLACEMENT FACTOR ON THE PERFORMANCE OF CONSTRUCTED DRAINAGE SYSTEM.

**Kachalla Mohammed.**

Civil and Water Resources Engineering Department, University of Maiduguri, N.E. Nigeria.

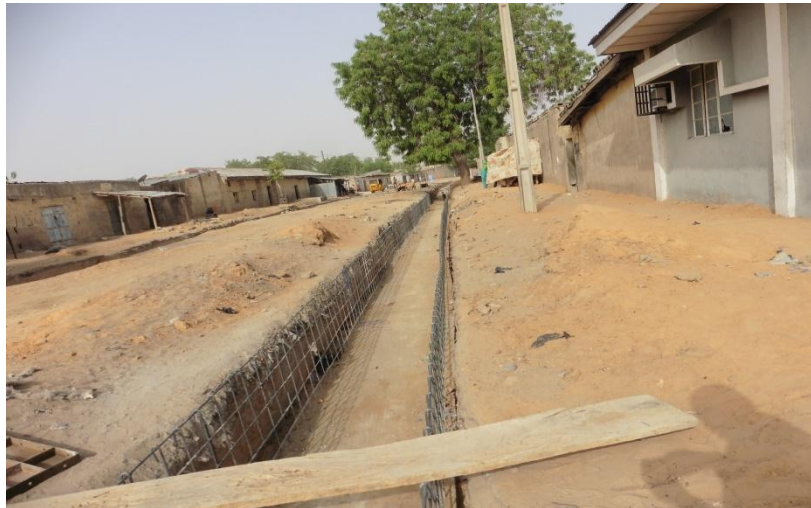
**Figure 1:-**Drainage under construction

Practical implementation of good design that will give the require safety and design economy requires good workmanship; that is the skill and construction quality put into completing a project to a clinical precision. Most often either due to carelessness or other associates factors, the workmanship error might greatly affect the performance of completed project. Figure 1 shows a typical good example for a construction of asphalt pavement with lined drainage. Several studies that were based on structured questioners are found in literature on workmanship related issues during constructions (Ali and Wen, 2011; Mark, 1997; Othman *et al.*, 2014). Those studies result reveals some key elements that affect the workmanship quality, and these includes among others are the skills and competency levels. Additionally, inadequate checks and construction control resulted in over 90% of project failure. Mark (1997) study result showed that poor workmanship quality would significantly reduce the serviceability reliability by more than an order of magnitude. The statistics is worrisome and challenging. No doubt, flexural reinforcement placement at its designated (tensile or compression) place plays a very important role especially with respect to the associated failure forms as earlier discussed. Evidently as shown using Figure 3, indicates a poorly placed flexural reinforcement and no corrective measures before concreting. Such situations are primarily due to poor workmanship or improper supervision at the construction site, and this cannot be quantified using structured questioners. Structural component failures are envisage under such situations. Hence, this study presents to evaluate the integrity or capacity performance of such system in meeting up its intended function using analytical method. This study outcome will enriched the literature significantly because presently there no available literatures on the effects of poor workmanship in placing flexural reinforcements for drainage system exposed to heavy trucks movement.

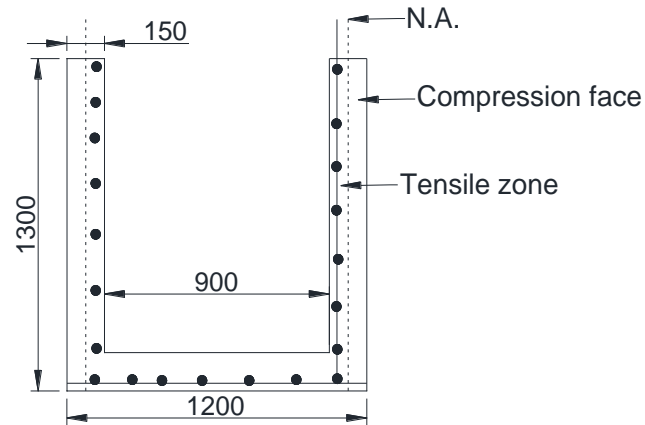
**Figure 2:-**Channel section.

The drainage is located at Ngomari Airport Road, off Kano road adjacent to Maiduguri International Airport. The road is a dual carriage-way having side drainage at its both side (Breath,  $B = 1200mm$  and depth,  $D = 1300mm$ ). The wall has a thickness value of  $150mm$  having a concrete cover value of  $30mm$  (Figure 2). The details for the flexural design parameters were obtained from the design engineer at the site, and informed the use of  $10mm$  bar both for the longitudinal and transverse directions spaced at  $250mm$  centers. The flexural reinforcement placement depth was varied during the numerical analysis in order to obtained the influence of haphazardly placed reinforcement within the wall. Three different locations are considered and these are  $30mm$  away from the N.A.,  $15mm$  away from the N.A (both within the tensile zone) and  $5mm$  after the N.A. point (which falls within the compression face). No attempt was made to verify the suitability for the design parameters given with respect design considerations. However, the analysis length was fixed to  $9700mm$ .

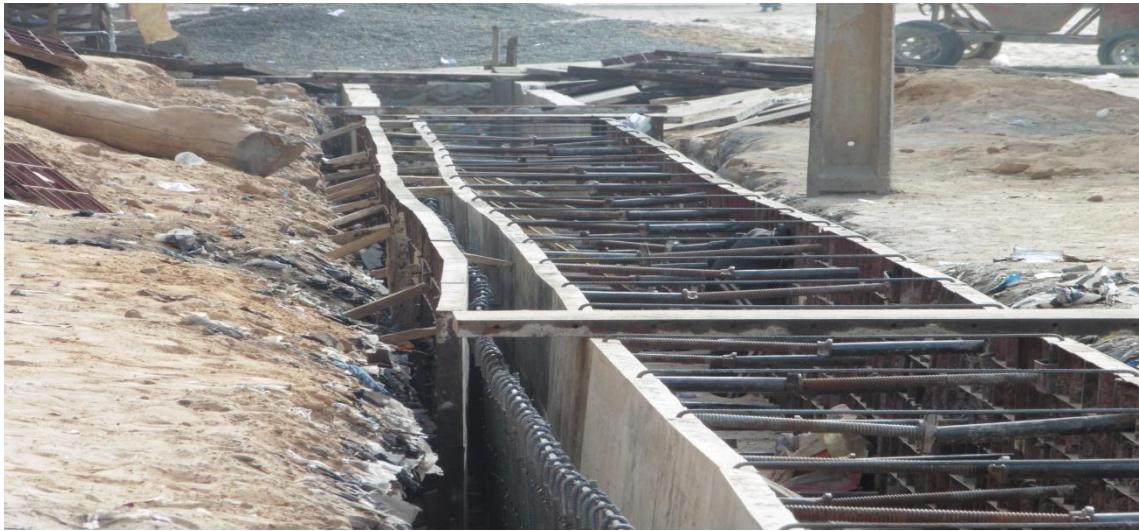
**Figure 3:-**Completed segment ready to be casted

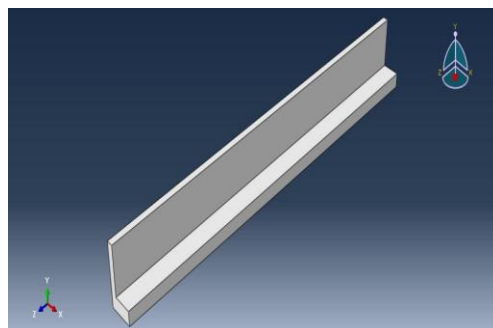
**Figure 4:-**Typical analysis section

This study uses ABAQUS application to determine the behavior for RC drainage. The flexural reinforcement placement position was intermittently changed from the tensile zone to the compression face with respect to the N.A. position. However, because of section symmetry, only the half of drainage section was subjected to analysis in this study (Figure 4). The finite element model considers both the non-linearity behavior of the concrete and reinforcement medium. The concrete part was deformable solid element while the reinforcement part is also deformable-wire element. The elastic material properties are given using Table 1.

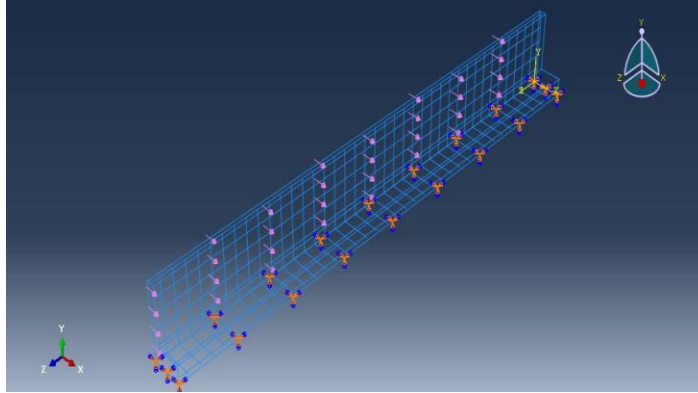
Figure 6:-Load and boundary definition

The newly constructed road under this study is open for use to heavy articulated vehicle. Therefore, this study uses a typical tire load value of 18.9kN and this translates to about 80kN under the equivalent single axle load (AASHO, 1961). Triangulation loading pattern was adopted and the boundary condition was fixed at the bottom (Figure 6).

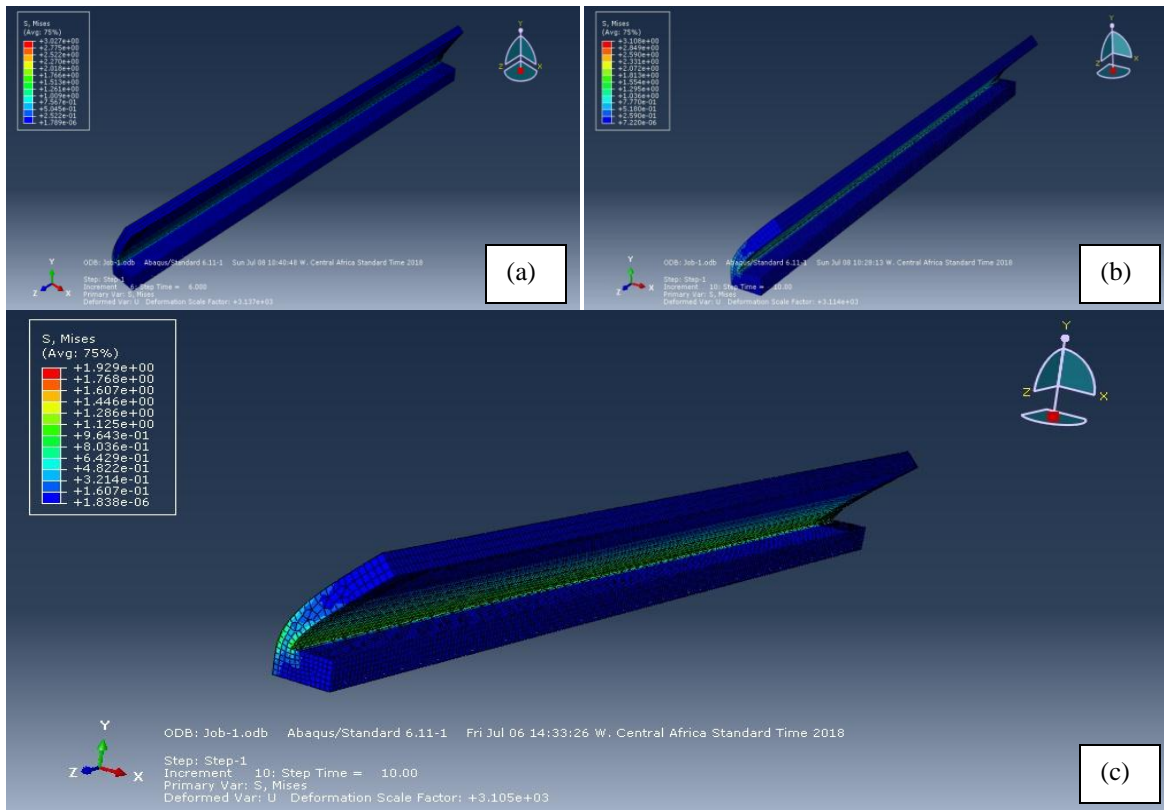
Figure 7:-Von Mises Stress (a) 30 mm away from the N.A., (b) 15 mm away from N.A. and (c) 5 mm after the N.A.

This section presents analysis result for this paper. Figure 7 shows the stress concentration at the stem-base connections with the varying wall-flexural reinforcement placement. In that figure, the stress value significantly increases with assumable wrongful flexural reinforcement placements (i.e 30mm to N.A. position - 5mm after the N.A. position). The result indicates that improper flexural placement at its designated place will lead to unnecessary stress built-up which have a far reaching consequences on the performance of the constructed drainage facility.
