#### MECHANISTIC ANALYSIS OF EARLY PAVEMENT DETERIORATION: APPLICATION TO THE GASSI - DOURBALI SECTION

**Maucord Mougabé Belem, Djegoldé Kormbaye and Nadjitonon Ngarmaim.**

Industrial Technologie Study and Recherch Laboraty (LERTI) at the University of N'Djamena Civil Engineering Laboratory (LABOGECE).

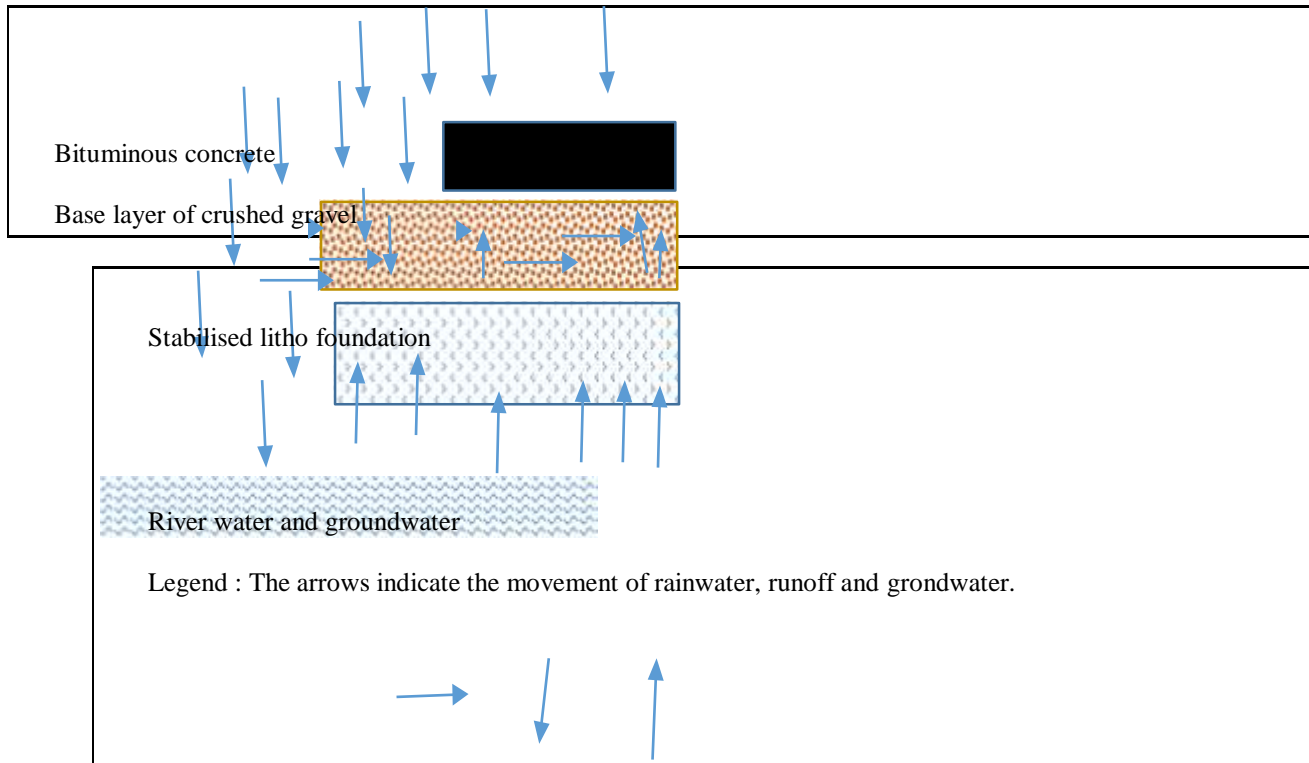
Figure 1:- Modelling.

- The sol-cement rejected during the checking mission was the best solution for a weak soil such as the clay base of the pavements. It would give rigidity to the sub-base and absorb the shocks transmitted to the sub-base soil, while reinforcing the waterproofing capacity of the sub-base. In this way, consolidation of the subgrade with the base soil would be more uniform. Below is a model of the behaviour of the pavement produced.
